New Hampshire Volunteer Lake Assessment Program

2002 Interim Report for Warren Lake Alstead

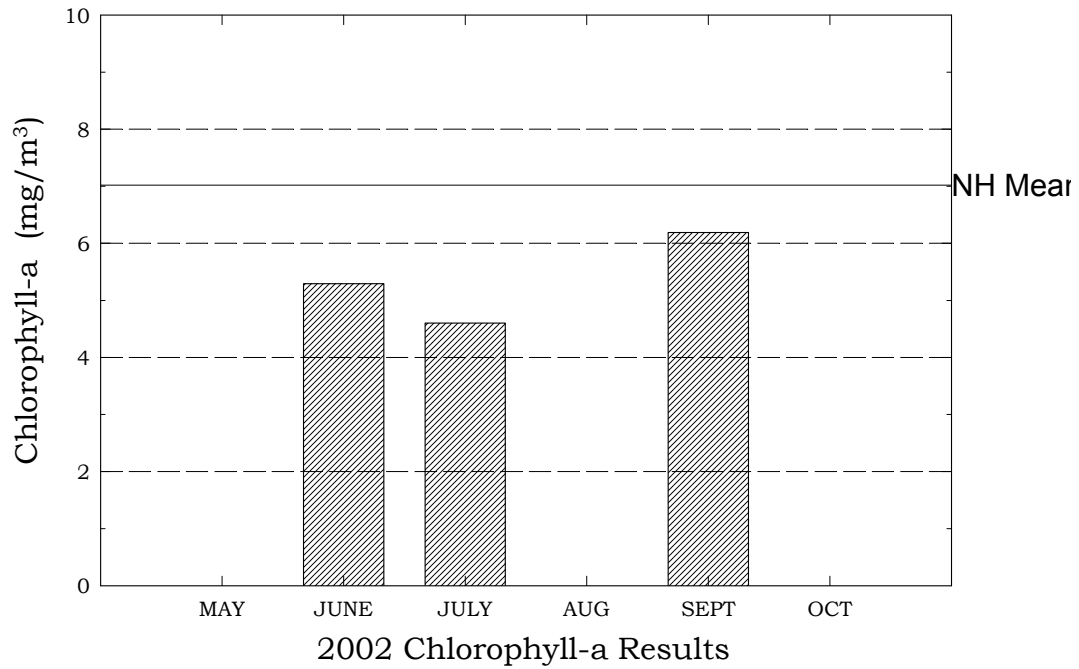
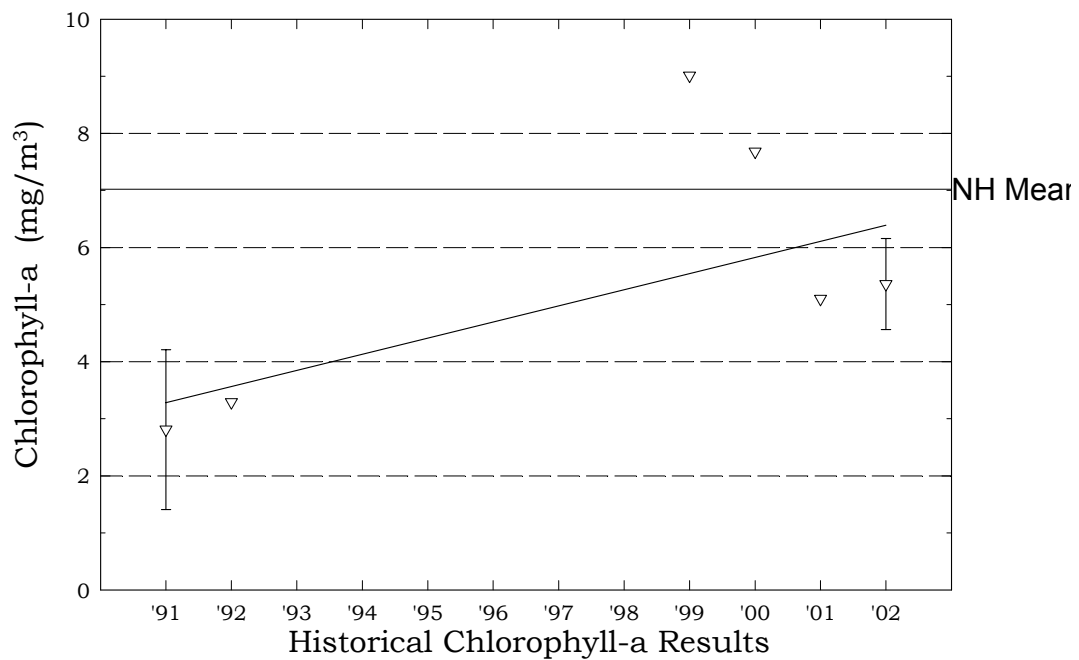
Figure 1. Monthly and Historical Chlorophyll-a Results

- **Figure 1 and Table 1:** The graphs in Figure 1 (Appendix A) show the historical and current year chlorophyll-a concentration in the water column. Table 1 (Appendix B) lists the maximum, minimum, and mean concentration for each sampling season that the lake/pond has been monitored through the program.

The historical data (the bottom graph) show that the 2002 chlorophyll-a mean is **less than** the state mean. Overall, visual inspection of the historical data trend line (the bottom graph) shows **a variable** in-lake chlorophyll-a trend, meaning that the concentration has **fluctuated** since monitoring began in 1991. (Please note that the lake was not sampled from 1993-1998.)

ecosystems, the chlorophyll-a concentration found in the water gives an estimation of the concentration of algae or lake productivity. **The mean (average) summer chlorophyll-a concentration for New Hampshire's lakes and ponds is 7.02 ug/L.**

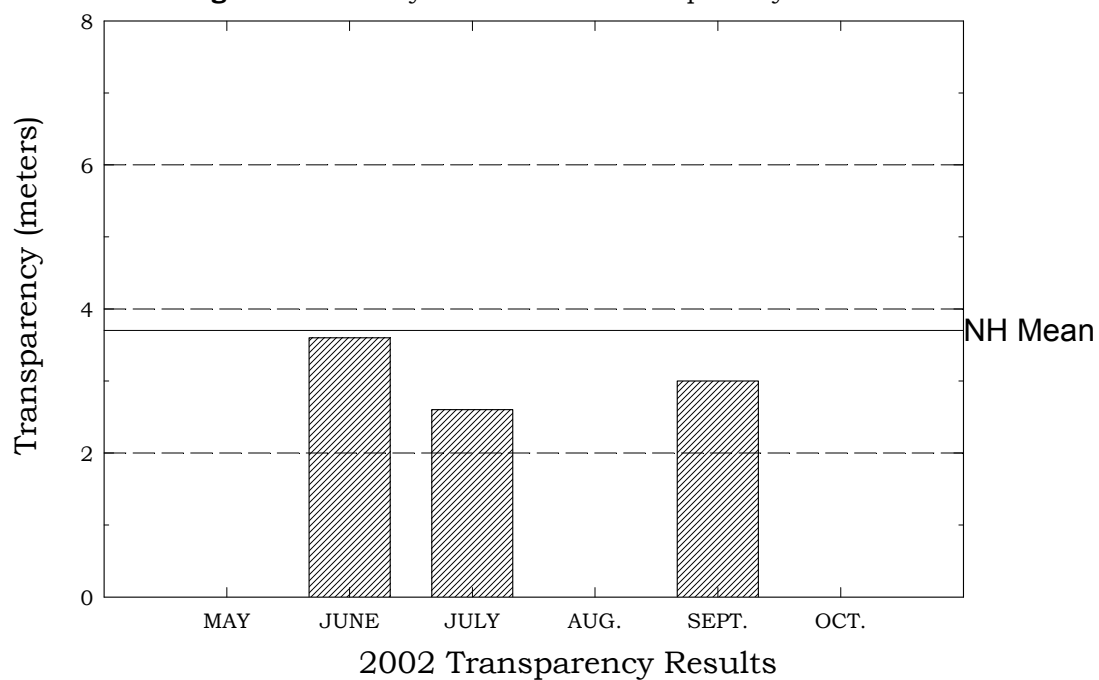
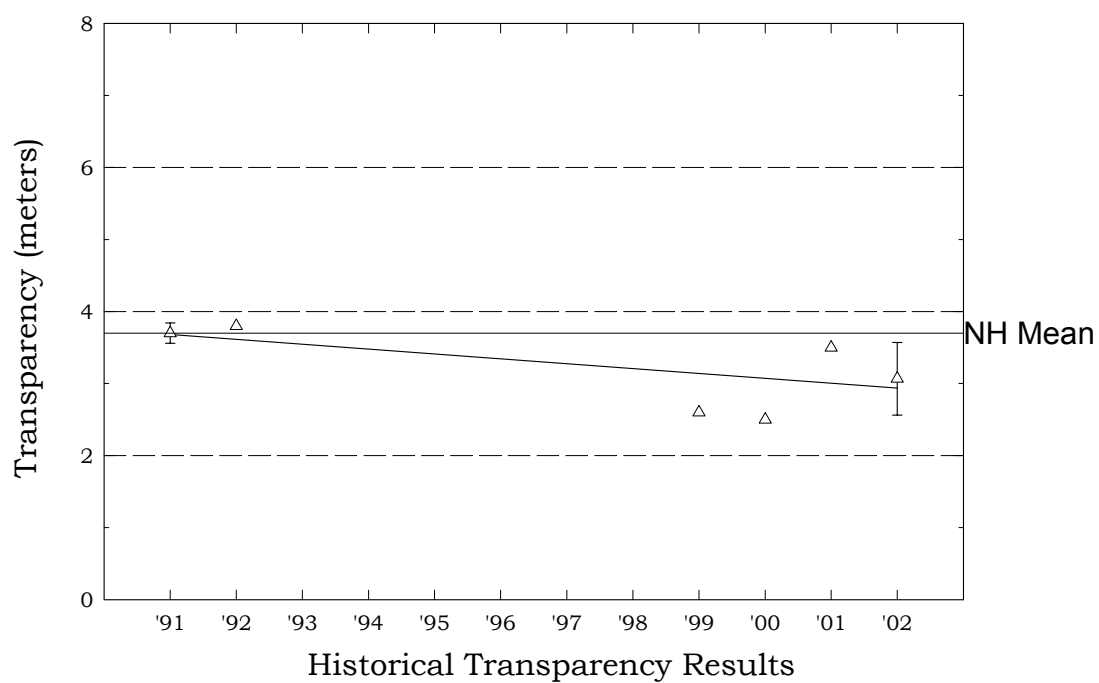
Figure 2. Monthly and Historical Transparency Results

- **Figure 2 and Table 3:** The graphs in Figure 2 (Appendix A) show historical and current year data for lake/pond transparency. Table 3 lists the maximum, minimum and mean transparency data for each sampling season that the lake/pond has been monitored through the program.

The historical data (the bottom graph) show that the 2002 mean transparency is ***slightly less than*** the state mean.

Overall, visual inspection of the historical data trend line (the bottom graph) shows ***a slightly decreasing*** trend for in-lake transparency, meaning that the transparency has ***slightly worsened*** since monitoring began.

Volunteer monitors use the Secchi-disk, a 20 cm disk with alternating black and white quadrants, to measure water clarity (how far a

person can see into the water). Transparency, a measure of water clarity, can be affected by the amount of algae and sediment from erosion, as well as the natural colors of the water. **The mean (average) summer transparency for New Hampshire's lakes and ponds is 3.7 meters.**

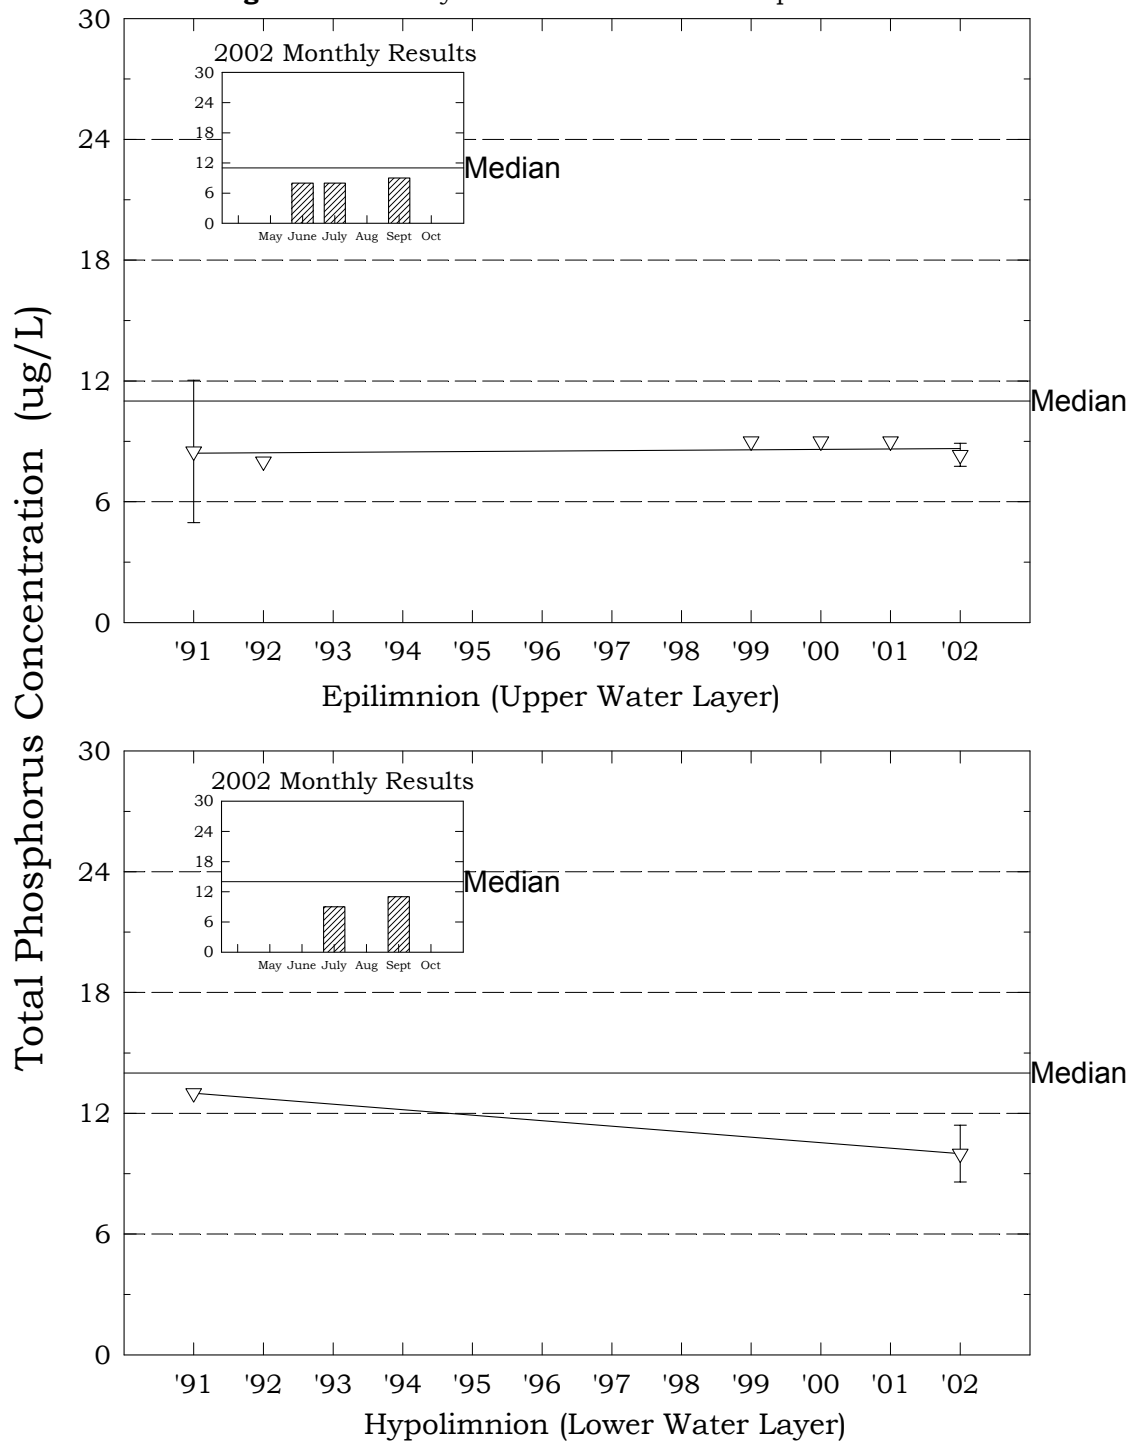
Figure 3. Monthly and Historical Total Phosphorus Data.

- **Figure 3 and Table 8:** The graphs in Figure 3 (Appendix A) show the amounts of phosphorus in the epilimnion (the upper layer) and the hypolimnion (the lower layer); the inset graphs show current year data. Table 8 (Appendix B) lists the annual maximum, minimum,

The historical data for the epilimnion (the upper graph) and the hypolimnion (the lower graph) show that the 2002 total phosphorus mean is **less than** the state median.

Overall, visual inspection of the historical data trend line for the epilimnion (the upper graph) shows **a stable** total phosphorus trend, which is **less than** the state median, since monitoring began.

Visual inspection of the historical data trend line for the hypolimnion (the lower graph) shows **a slightly decreasing** total phosphorus trend, which means that the concentration has **slightly improved** since monitoring began. We hope this trend continues! (However, it is important to keep in mind that this trend is based on a limited data set since the hypolimnion has only been sampled in 1991 and 2002.)

Phosphorus is the limiting nutrient for plant and algae growth in New Hampshire's freshwater lakes and ponds. Too much phosphorus in a lake/pond can lead to increases in plant and algal growth over time. **The median summer total phosphorus concentration in the epilimnion (upper layer) of New Hampshire's lakes and ponds is 11 ug/L. The median summer phosphorus concentration in the hypolimnion (lower layer) is 14 ug/L.**
